# HERITAGE IMPACT ASSESSMENT

# 295 Jarvis Street

Toronto (GBCA Project No: 18010)

**Date of submission** 17 May 2018

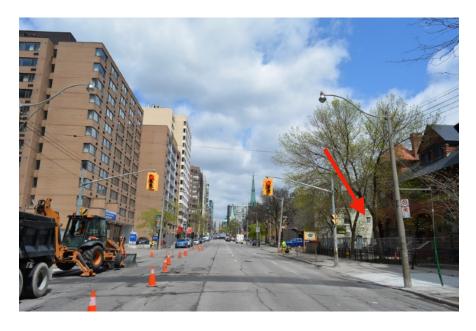
# Above left:

Looking north on Jarvis Street. The development site is indicated by the red arrow. The area on the west side of Jarvis Street is currently characterized by mid to high rise residential buildings.

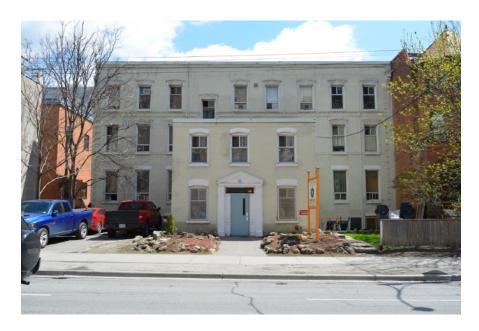
# Above left:

Looking towards the subject site and the main (east) elevation of the existing building, occupied by Inglewood Arms Hotel.

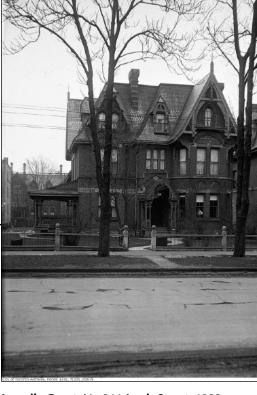
**Juvenile Court, No.311 Jarvis Street, 1923**

The High Victorian building was a single family residence that was converted as a Juvenile Court and Detention Home in the 1920s. It was demolished in the late 1940s to make way for a larger facility which still stands today.

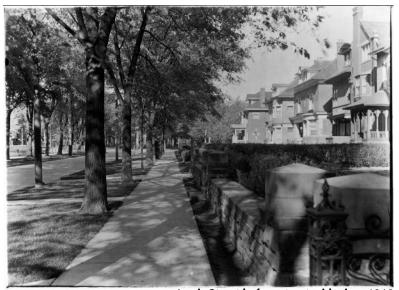
City of Toronto Archives, Fonds 1244, Item 7097

Jarvis Street before street widening, 1910

The plan in 1930 to extend Jarvis Street north of Bloor to connect with Mt. Pleasant Road ultimately transformed Jarvis Street into a major thoroughfare linking the northern suburbs with the downtown. This would serve to accelerate the decline of the grand residential street, leading to the removal of trees and the landscaped boulevard in 1947 to widen the street to the increasing traffic. And thus, by the mid-twentieth century, Jarvis Street was beginning to take on a much different appearance and image. With increased vehicular traffic using Jarvis Street as a main access route to the downtown core, a number of gas and service stations began to appear, primarily at the corners of the cross streets.

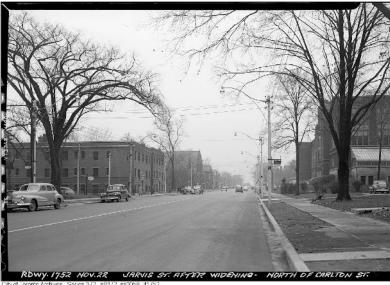
Jarvis Street after street widening, 1947

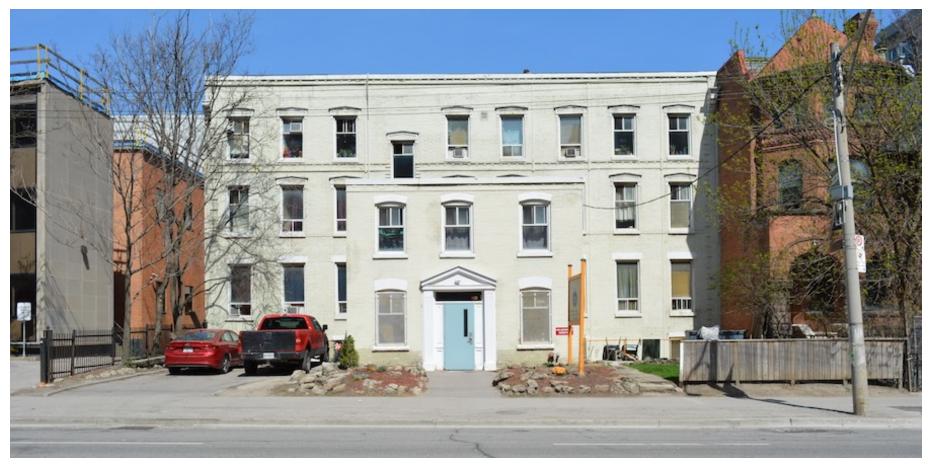
West (main) elevation of the Inglewood Arms Hotel at 295 Jarvis Street

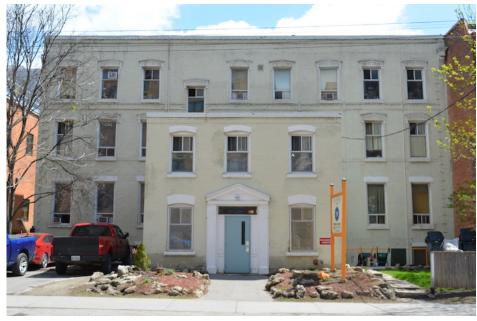
#### Above left:

Close-up view of the top north portion of the Jarvis facade. Brickwork attempt to emulate corner quoins. The lower level shows evidence, in the brickwork, of an alteration to remove what would have been an entryway and replace it with a new window opening (see red arrow). The fourth bay top window (green arrow) has a window hood and the brickwork at the jambs suggest that this window is original and that the "misalignment" is intentional.

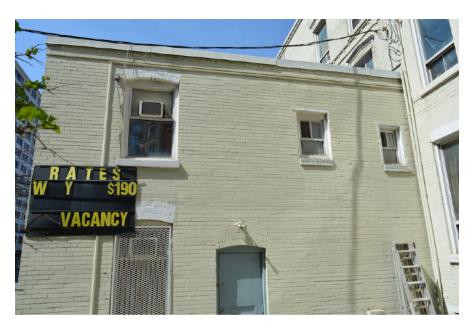
# Below right:

View of the two-storey addition's south wall. Window and door openings vary in size and alignment. Note the sills and lintels of the smaller windows, which consist of bricks.

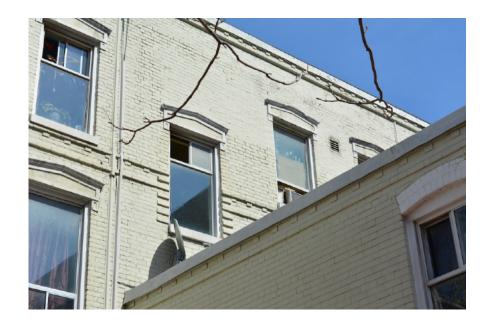
View of the east (rear) elevation of the main building (marked by the wall with no asphalt roofing - see key plan). The paint on the brick is peeling off and in some areas there are traces of spalling brick. Original window openings have been visibly blocked off.

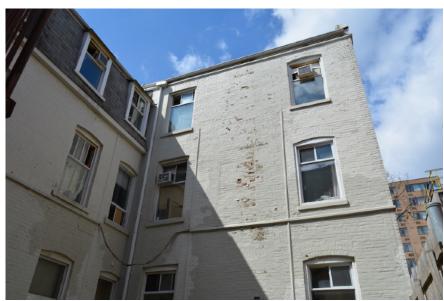
Close-up view of a wall in the interior courtyard (see key plan). Fire insurance maps suggest this wall is original to, likely, the 1850s although was clearly built as a secondary wall with limited design consideration. Misalignment and varying sizes of the window openings were most likely a result of later alterations. A portion of the water table is covered in cement parging (red arrow)

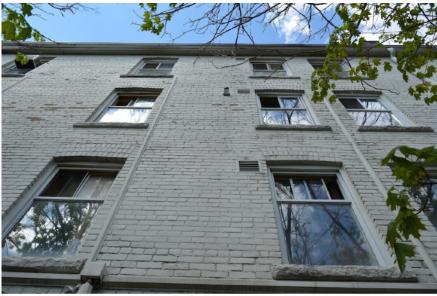
Close-up view of a rear wall facing George Street (see key plan). This wall appears in the 1913 Fire Insurance Map and most likely is original to that time period. As a rear wall, it was designed with limited design consideration . Window openings appear original. The brickwork is in fair condition with no visible signs of significant deterioration, other than the peeling of the paint from the brick surface. Mortar joints are deteriorating in select locations. All windows are modern replacements and their style vary throughout this facade, as is the case for the rest of the building.

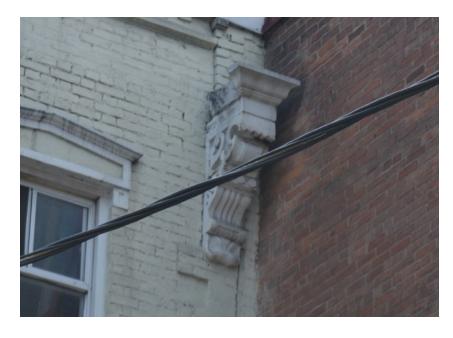
Above:

Two elaborate stone brackets are fixed at the top storey below the parapet. Both brackets are partially damaged and in fair to poor condition.

South stone bracket. The capital above the bracket is damaged (missing a piece)

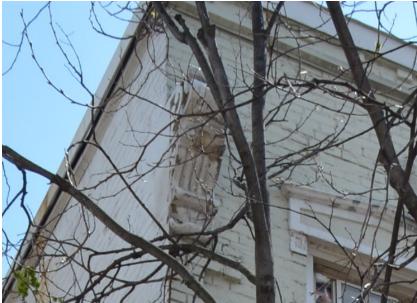
Below:

North stone bracket. The capital is missing.

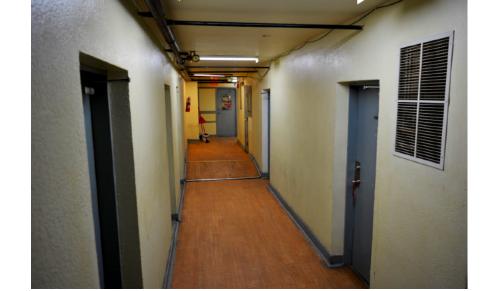
Above:

View of a typical room.

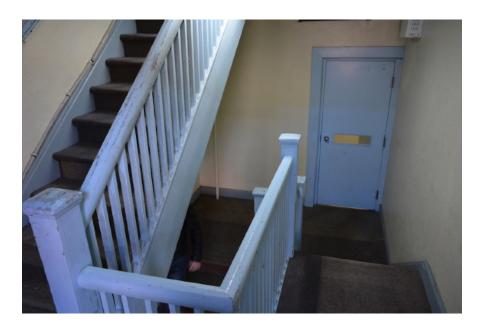
A typical stairwell shows that the staircase, baseboards and window trims are of an 1900s vintage, which most likely dates to the timing of establishment of the hotel in 1915. They are in good condition.

View of a staircase, which appear to be of the same time period than the establishment of the hotel in the early 20th century.

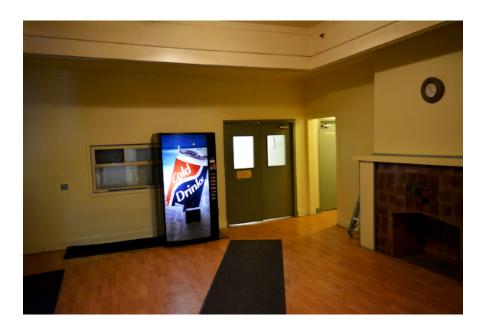
#### Above:

The main lobby of the building is square in plan and appears to have retained its original design intent, finishes and detailing. Of particular note is the ceramic tiled fireplace, which includes a coat of arms, most likely of the "Inglewood Arms" Hotel as well as a medallion engraved with a sailing boat and oars. This medallion most likely is a remnant of an earlier period than the Hotel.

Overall view of the main central lobby. Wall and ceiling finishes appear to be original. Current flooring is a modern replacement.

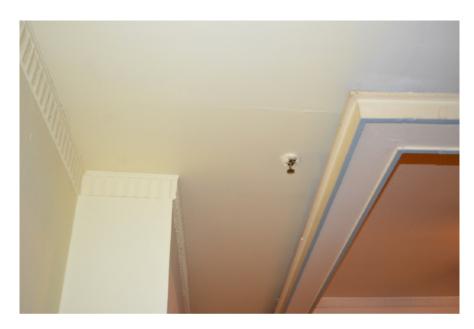
# Below right:

Close-up view of the ceiling in the lobby, noting the fluting details of the wall to ceiling junction.

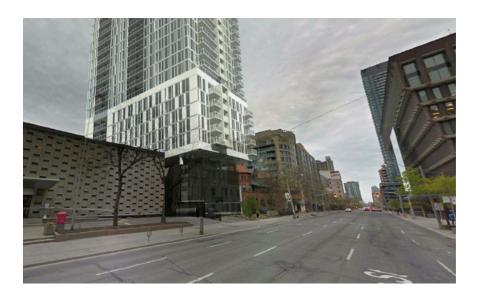
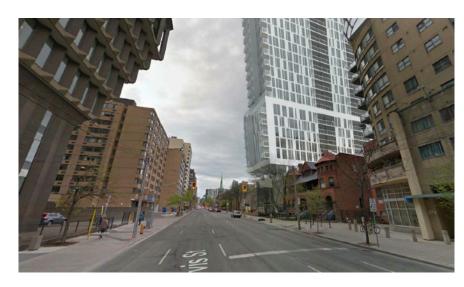
Perspective views looking, respectively, south and north on Jarvis Street, showing the relationship of the proposed development with the existing context. Note the presence of high-rise development in the vicinity, and not visible in the streetview are two 50 storey towers proposed on the NE and SE corners of Jarvis and Dundas(Core Architects)

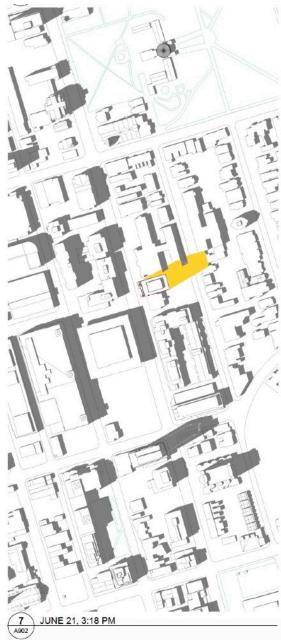
Shadow impacts have been prepared for this development and are available as part of the development drawings in Appendix I. Included on this page is an example for June 21st at 3.18pm, by Core Architects.

Due to the number of tall buildings on Dundas Street that are completed or currently under construction, along Dundas Street East, shadows are present in the area. The proposed development, north of the subject site known as 319 Jarvis, if approved, will also contribute to the shadowing in the area.

It is noted that summer shadowing will occur over heritage properties fronting the east side of George Street, which will be integrated into a future redevelopment. This shadowing will start in the mid afternoon and will move incrementally along George Street.

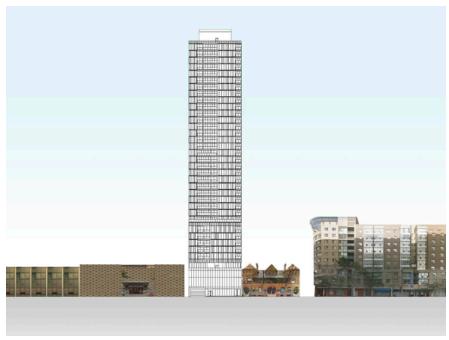
Viewed along Jarvis Street, looking north and south, the existing heritage property at 289-291 Jarvis Street will be visible and not significantly obstructed. The substantial stepback at the fourth level will allow the northern turret to be visible in the presence of a high-rise development on Jarvis Street. Further, the heritage building itself has a discreet presence on the street and, being hidden by trees, emphasizes its privacy. The massing of the proposed development adjacent to the row housing will therefore not significantly impact this character and will remain visible from different perspectives.

Overall Jarvis Street elevation drawing (Core Architects)
