# THE JORGENSON HALL

ASC 735 Heritage Conservation Theory and Practice  
Ryerson University, Department of Architectural Science

Assignment 1  
Instructor: Joey Giaimo

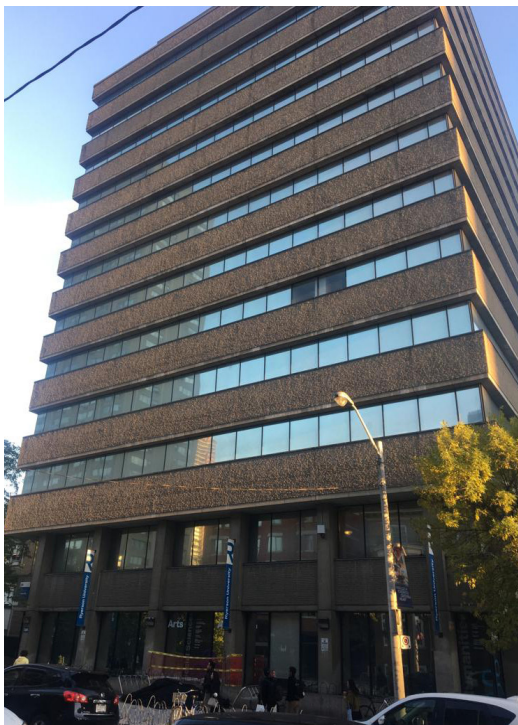
Bottom floors of the Jorgenson Hall.  
Source: *(Own work, 2019)*

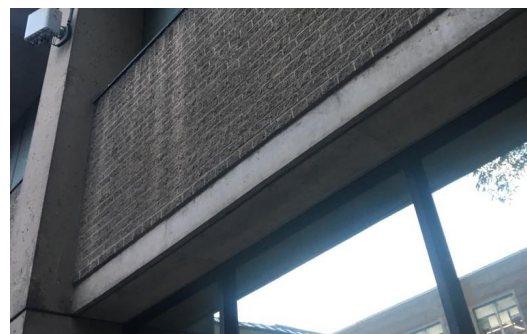
Detail materials of the Jorgenson Hall.  
Source: *(Own work, 2019)*

'Brutalism' is the word that describes the architectural style of the Jorgenson Hall. The cubic and orthogonal shaped building is executed in raw concrete and bricks, alternated with horizontally oriented windows. According to A. and P. Smithson brutalism has to be seen as a form of "raw poetry" in which the honesty of the construction is shown on the inside as well as the outside of a building. (Smithson, A., Smithson, P.; 1957) That same honesty is being shown in the relation between function and façade. In the first sketch below is visualized how the outside of the building shows the separation of the main circulation area (red part), the President's and dean offices (green part) and the left over administrative facilities (blue part).
