ANGLO-ONTARIO FARM BUILDINGS

An Architectural History Theme Study

David Butterfield
Historic Resources Branch

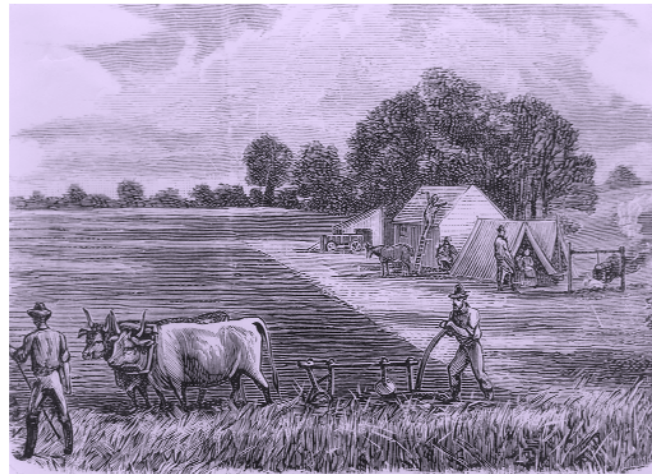
Figure 1

"Breaking the Prairie," ca. 1880. This idealized illustration shows the progression of habitation. While the first crop is being prepared other members of this pioneer group construct a small frame house. The tent in which the settlers are still temporarily living will soon be vacated. (Provincial Archives Manitoba.)

Initial structures built during the 1870s, like tents, lean-tos, sod huts or crude log shanties offered a rudimentary, yet quick, means of providing shelter for humans and animals (Figure 1). Throughout the first stage of settlement, the location of a water source was the dominant factor in determining the yard's layout. The barn was placed closer to the water source to provide easier handling of water for livestock. At this time, both the barn and the house were approximately the same size. Within the yard, these first crude buildings were generally arranged in a cluster for three reasons: to make access between buildings easier, to provide shelter from the prevailing northwest winds, and finally, to contain the buildings within a fireguard trench dug around the yard. The average homesteader built few additional storage structures at this time, as available money was spent on land, seed and farm equipment.

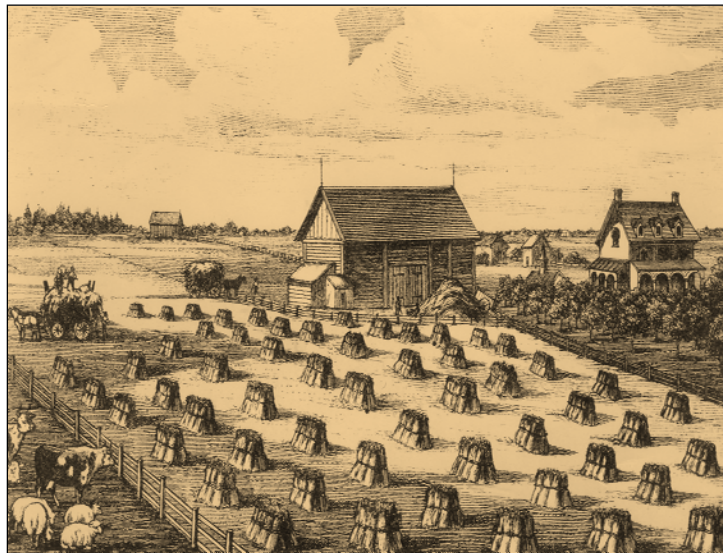
Figure 3
Six years after settlement on the prairie. An elaborate house and a large frame barn now dominate this neat little farmyard. (Provincial Archives Manitoba.)

The three stages in the development of residential architecture around Brandon, illustrated in the previous two figures (1 and 2) and also in Figure 3, can be easily distinguished, but they are difficult to date precisely. Although log houses were generally the first type of house built in the area, many log structures continued to be constructed after the turn of the century, while the small-scale 1½ storey house was the most prevalent house-type for the first fifty years of settlement.

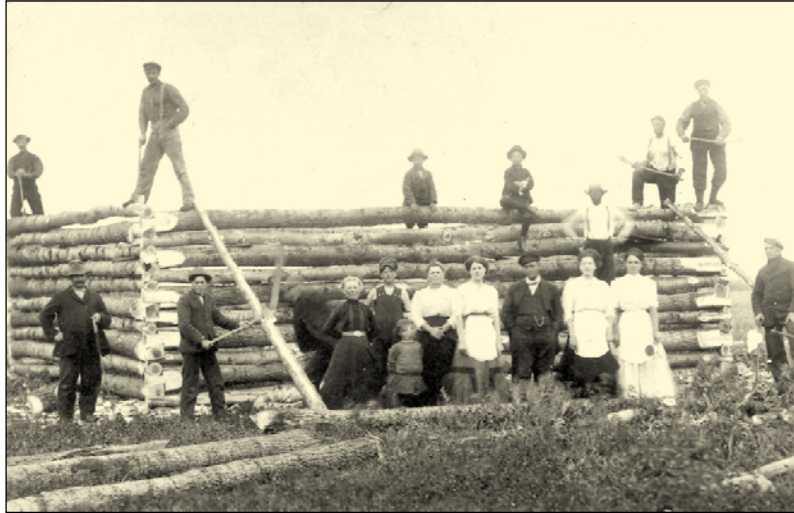
Figure 4
Log home under construction, Somerset,
ca. 1900. (Provincial Archives Manitoba.)

This stage of settlement, during the late 1870s and early 1880s, was difficult and it took some time before homesteaders were able to adjust to the hard work and the harsher climate on their new farms. Some remained until the 1890s in the initial conditions of settlement, living in shacks and subsisting on meager crops. Many settlers, however, adjusted to the difficulties of their new life and within a few years were able to harvest good crops and even encourage family relations from the east to venture west. The stability of their lifestyle at this time permitted many homesteaders throughout the west to consider the construction of a better house. Well-crafted 1½ storey log houses were usually constructed, although some sod houses were also built (Figures 4 and 5).

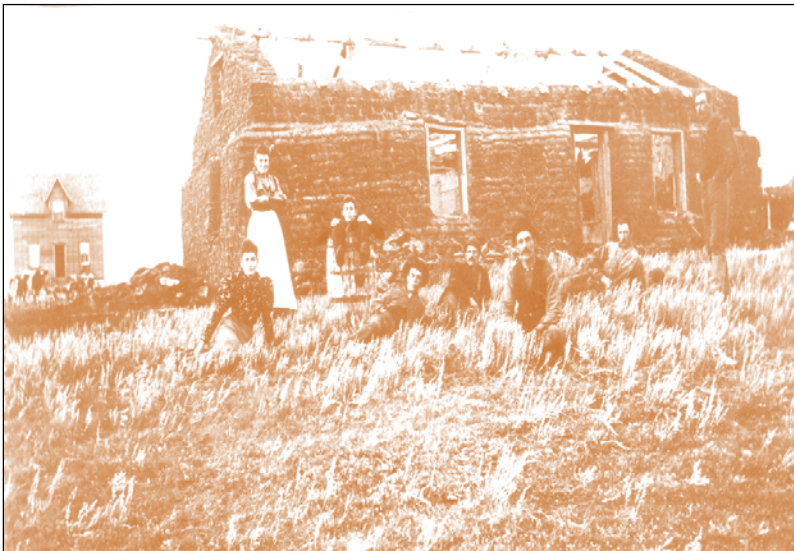
Figure 5
A Sod home, ca. 1900. (Provincial Archives
Manitoba.)

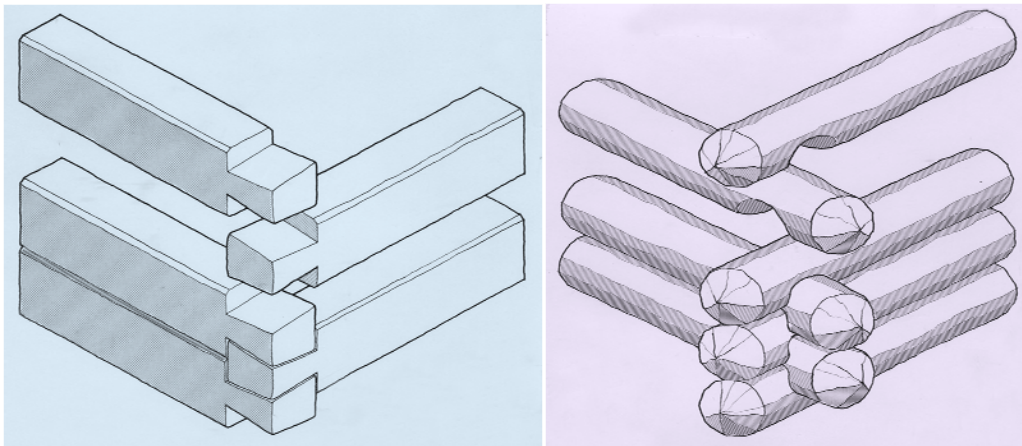
Figure 6

Dovetail construction (left) entailed cutting a wedge-shaped joint at each end of the squared logs. The logs were lapped at the corners and joined in an interlocking system that created a strong neat corner and ensured a waterproof joint.

In saddle-notch construction (right), round logs were lapped and, at the corners, curved notches were cut about a foot back from the end of the log. The location of the saddle-notch on the bottom of the log was more desirable as it allowed water to drain downwards, reducing the possibility of rain gathering in a top-notch and rotting the joint.

A simple medium-pitched roof and a small rectangular plan characterized the form of early log houses. Constructed by placing large logs one atop the other, log buildings required a corner joint that locked the walls together. Only a limited variety of notches were popular in the Canadian west during the nineteenth century. Dovetail joints and saddle-notch joints were the two most common methods of connecting log walls (Figures 6 and 7). While both notching procedures could produce joints of exceptional quality, the saddle-notch in this area was typically the earlier and less refined construction method. One of the first settlers in the area, the Reverend George Roddick, built a log cabin with saddle-notched corners although it is unclear whether he used a top or bottom notching procedure (Figure 8).

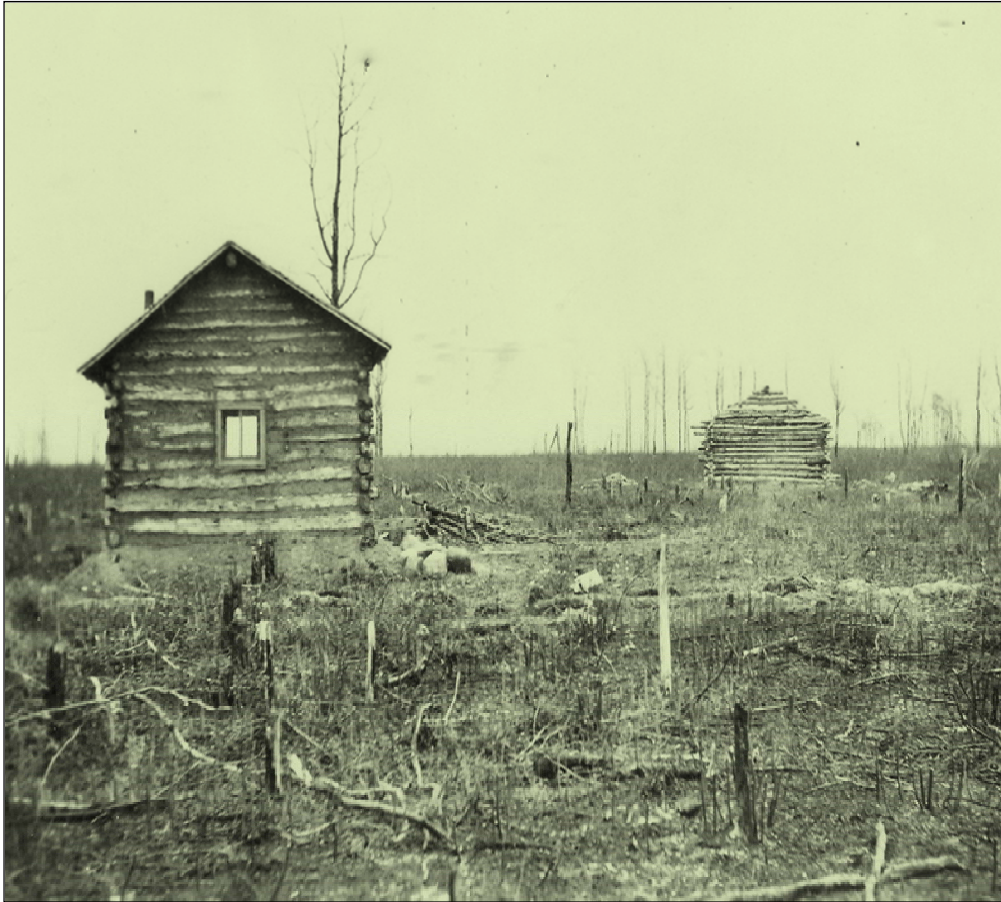
Figure 8
Reverend Roddick log cabin, SE 17-9-18W, ca. 1879. This house was probably one of the first built in the planning district, and this image suggests the rough pioneer experience. (Murray McPherson.)

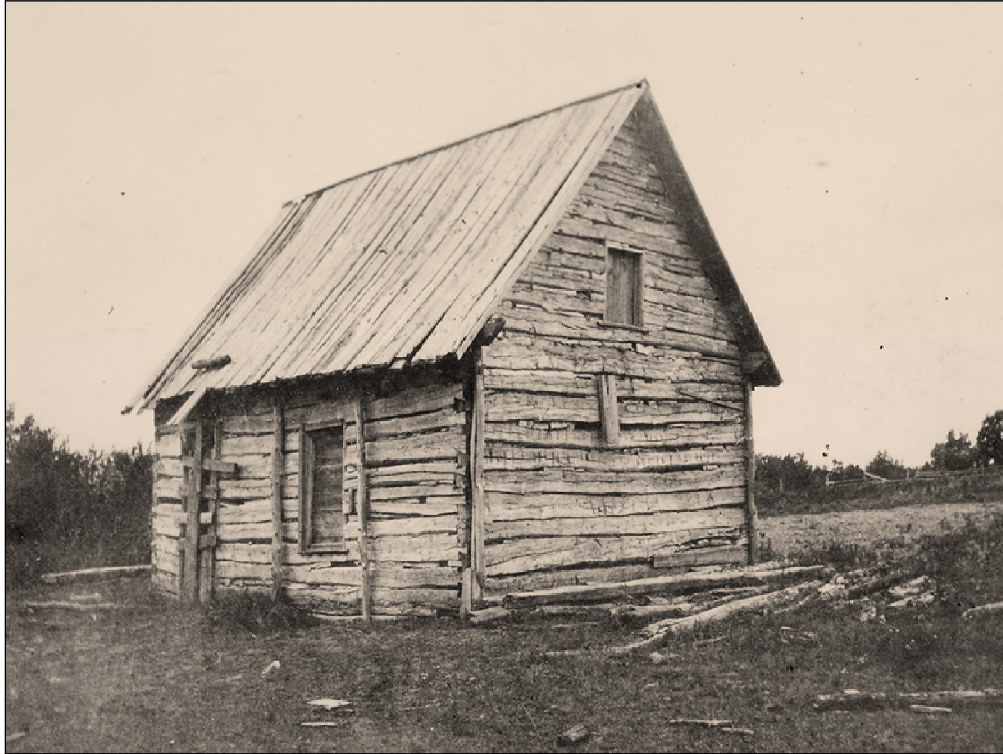
Figure 9
Reverend Roddick log house, SE 17-9-18W, ca. 1900. This dovetail-joined log house was dismantled in the 1950s. (Murray McPherson.)

Dovetail joining in Manitoba was usually more sophisticated than saddle-notching. Within the region there were no log houses located during the survey although a photograph of Reverend Roddick's second house reveals dovetail joinery (Figure 9).

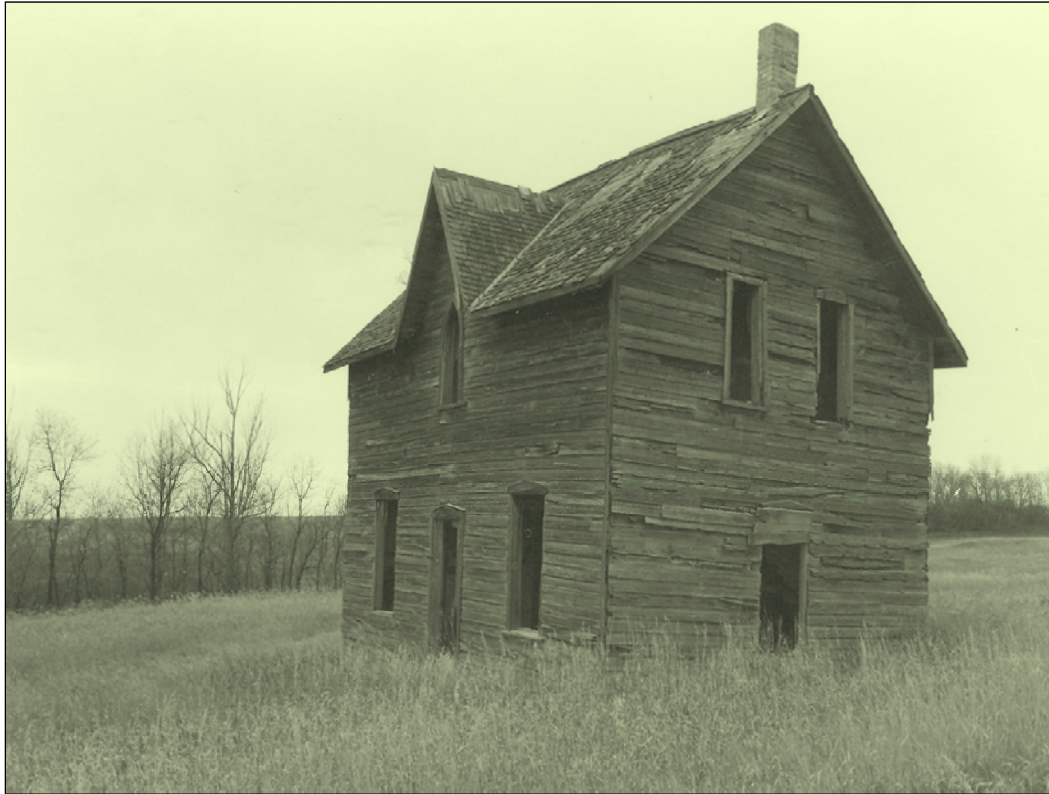
Figure 11

Symmetrically-planned 1½ storey house, SE 28-11-17W, ca. 1885. Although abandoned and in disrepair, the presence of square nails and pedimented window caps date this house as a pre-1900 construction.

The first type was based on houses familiar to settlers who had migrated from southern Ontario (Figure 10). An abandoned house at SE 28-11-17W is a typical example of this residential type (Figure 11). The front of the house was on the long side of the rectangular floor plan (Figure 12 and 13). The door was nearly always centrally placed creating a symmetrical facade that was accented by a central gable (Figure 14). Internally the house contained a central hallway, sometimes running from front to back, effectively dividing the ground floor in two, with rooms on each side.

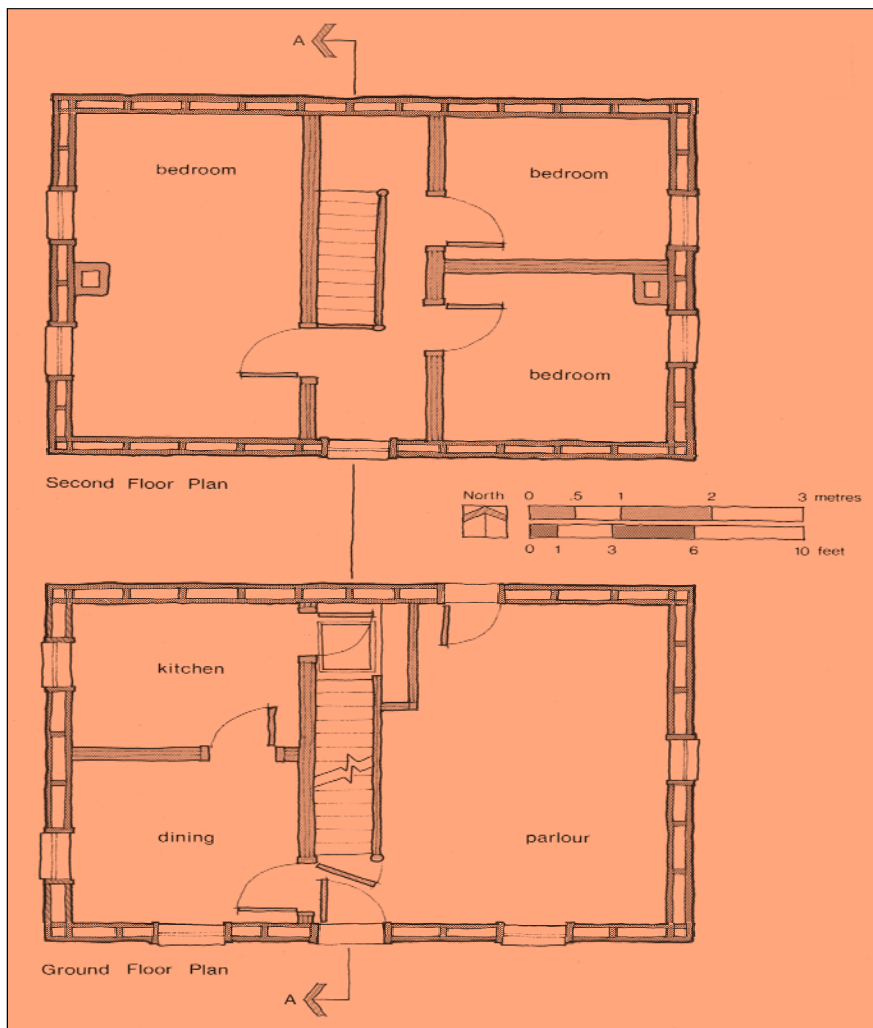
Figure 12
 Symmetrically-planned 1½ storey house: ground floor and second floor plans. New settlers in the west could hardly afford the time or money to construct elaborate stone houses. Instead, they often chose lumber.

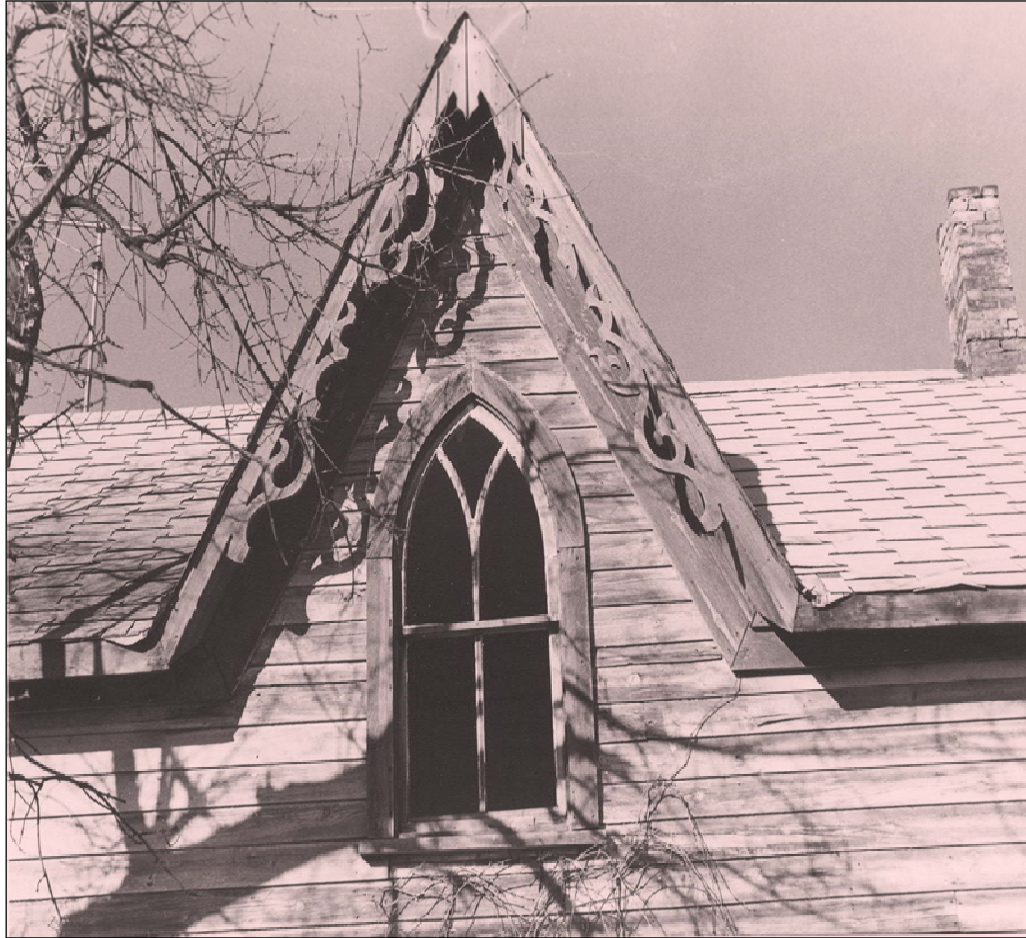
Figure 14
Gothic-style pointed windows and central gables with bargeboards were usual motifs of the symmetrically-planned small-scale house.

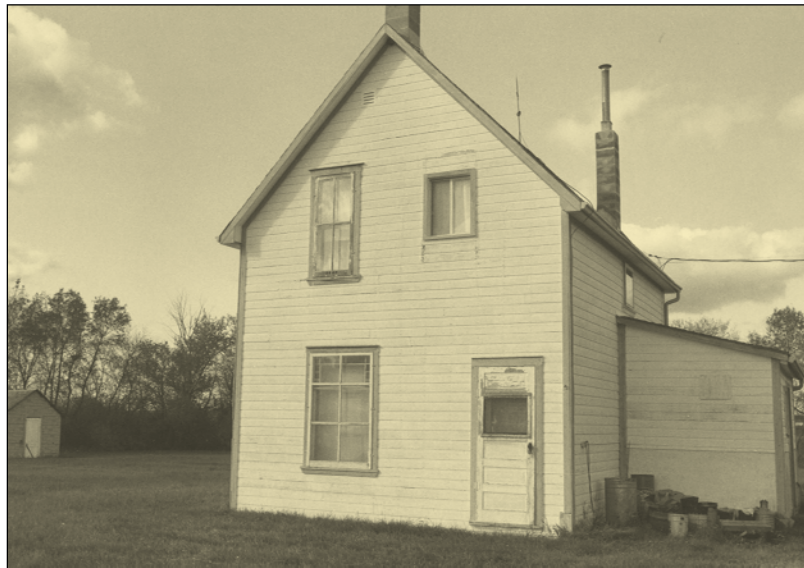
Figure 15

Side hall-planned 1½ storey house, NW 3-12-19W, ca. 1900. Although round nails in the main structure of this house imply that it was built around 1900, its basic form, planning and fenestration reflect the basic rectangular house type built fifteen years earlier.

The second basic house type built before the turn of the century in Elton-Cornwallis was plainer in appearance than the type transplanted from southern Ontario. A house at NW 3-12-19W is a fairly well-preserved example of this type of small-scale frame construction (Figure 15). One-and-a-half storeys like the previous type, the basic differences between the two relate to their internal planning and the consequent changes in fenestration patterns. This second type of rectangular house had its front on the short side of the floor plan (Figure 16). To make the most efficient use of interior space, the front door would be placed to one side creating an asymmetrical and vertically massed front. Internally, on the ground floor, the hall was located to one side at the front of the house (Figure 17).

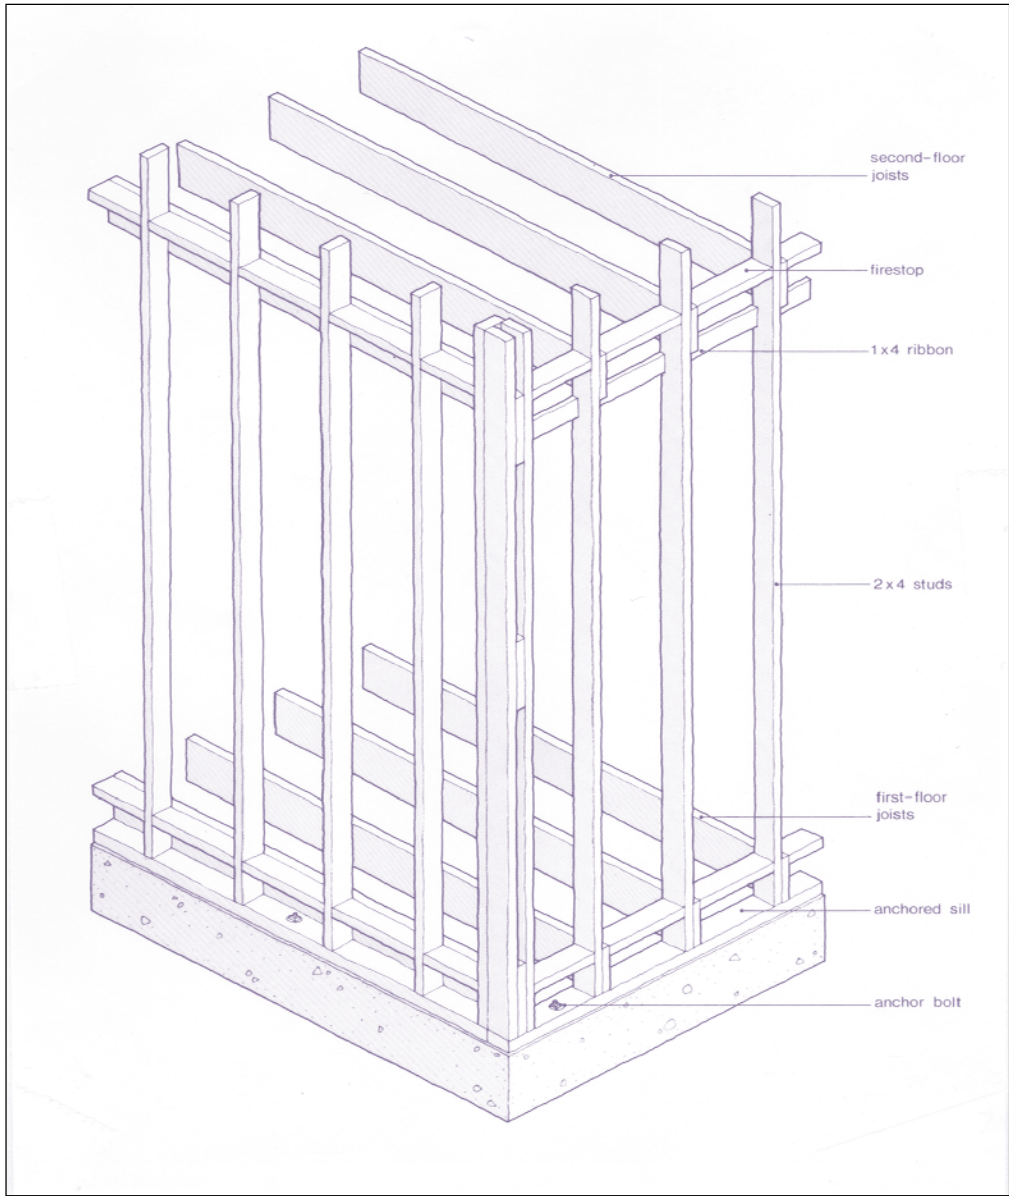
Figure 18
Balloon framing construction.

Balloon framing permitted quick and easy construction of the exterior frame and the addition of the roof before interior work was begun (Figure 18). The addition of the roof at this stage allowed work to progress inside during inclement weather. The actual construction procedure entailed the attachment of 40 x 80 mm (2" x 4") studs to a sill plate that was secured to the foundation. The stud walls extended in one piece up to the plate supporting the roof. Floor joists, supported by ribbon boards, were nailed to the individual studs.

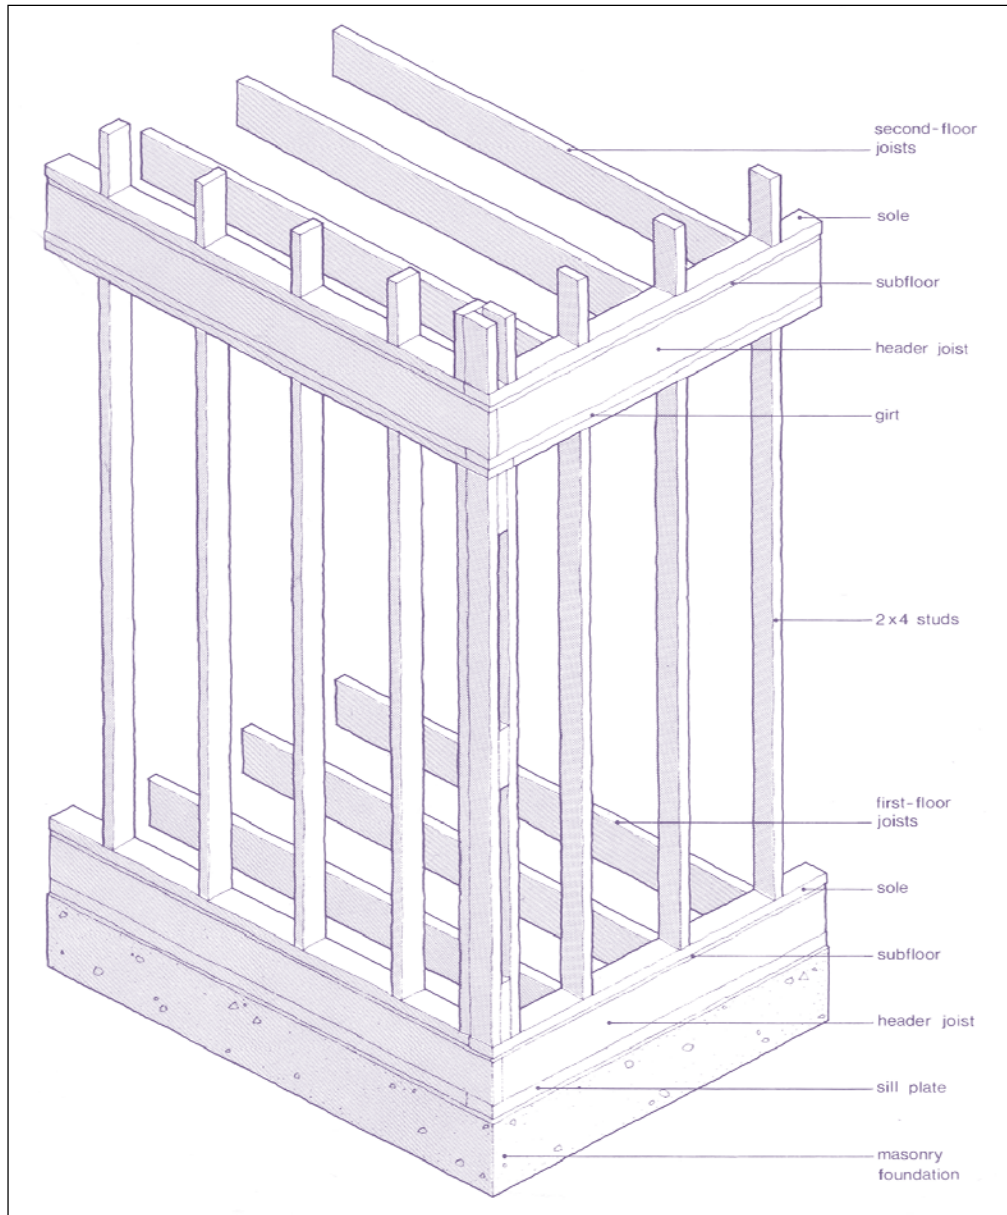
Figure 19
 Platform framing procedure. Each floor was built separately. The stud walls were assembled and arranged at each succeeding stage of the construction.

The platform framing procedure eliminated the need for long 40 x 80s (2" x 4"s) and also permitted construction in stages (Figure 19). Each stud wall, which extended only one storey, was pre-assembled as a unit at each succeeding stage of construction. The individual walls were fitted into prescribed vertical positions and secured to horizontal plates.

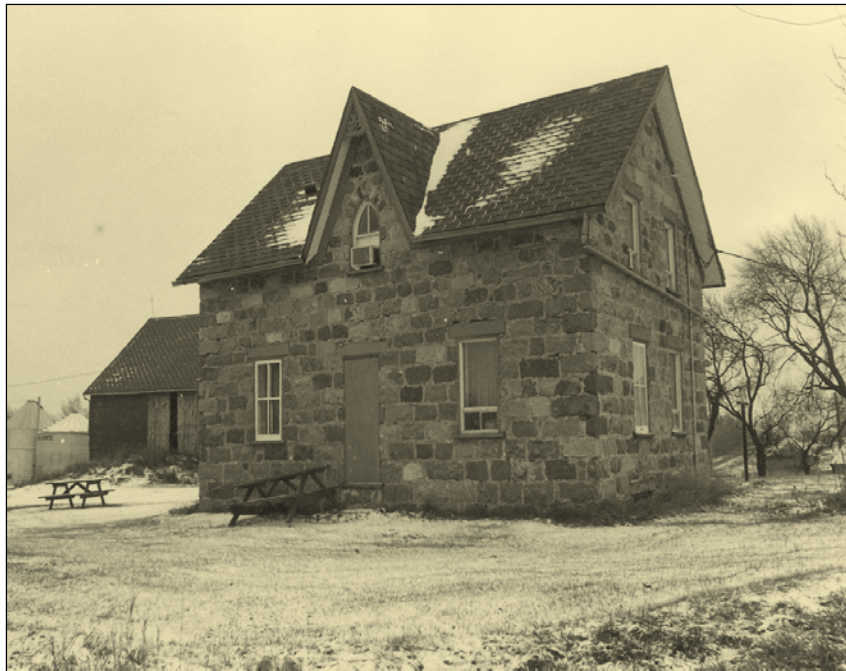
Figure 20

Centrally-planned 1½ storey stone house, NE 21-9-18W. The well-cut blocks of this symmetrically-planned house recall the more elaborate stone houses of southern Ontario. The house was used from 1907 to 1915 as the Brandon Hills Post Office.

Fieldstone houses varied both in terms of appearance and construction procedures. Fieldstone rubble of different sizes bonded with large amounts of mortar resulted in rough walls that were often covered with plaster outside and wood lath and plaster inside. Neater, more elegant stone houses required the skills of a mason. Carefully-cut and faced stones, bonded with small amounts of mortar, created straight, solid walls. A house at NW 21-9-18W is a symmetrically-planned house executed in fieldstone (Figure 20).

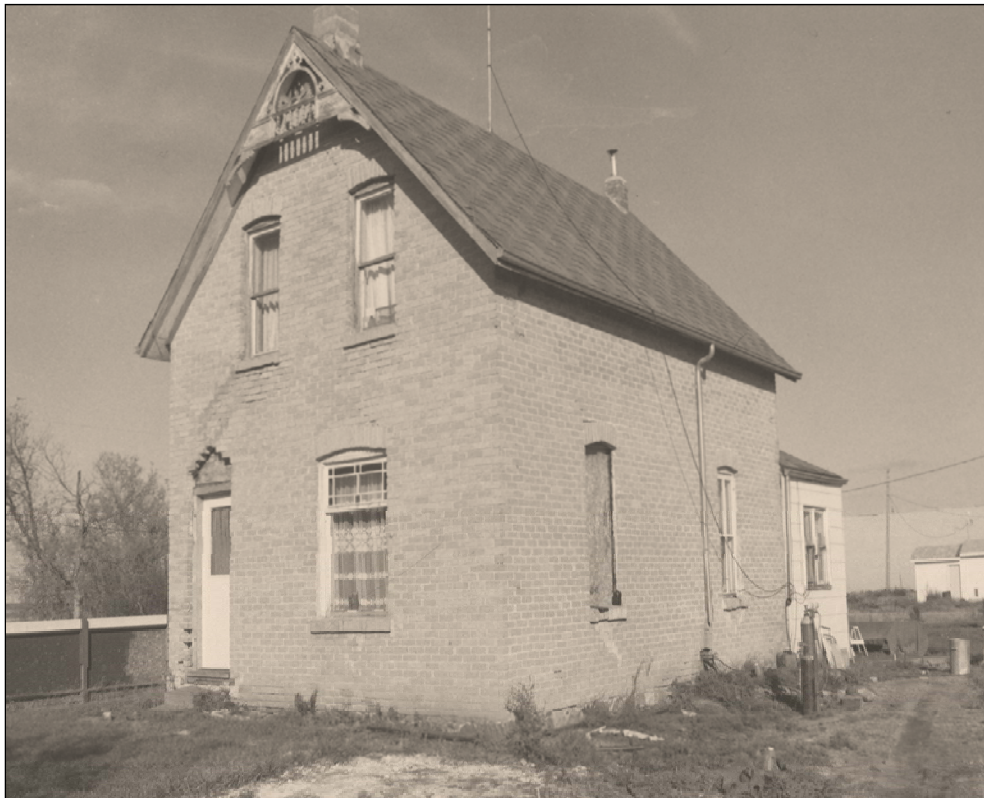
Figure 21

Side-hall planned 1½ storey house, Forrest. A more elaborate version of the second common house type is created in this Forrest house using buff brick veneer, extended proportions and detailing in the parlour window and gable peak.

The use of brick veneer was not common for the construction of small-scale residences. Indeed, there are only two existing small-scale brick residences left in the planning district. Brick was expensive before the turn of the century and the construction procedures were labour-intensive. Erecting a frame for small-scale house and then covering it with brick was unaffordable for most farmers in the area. A house in Forrest is a more substantial brick veneer version of the second basic house type (Figure 21).

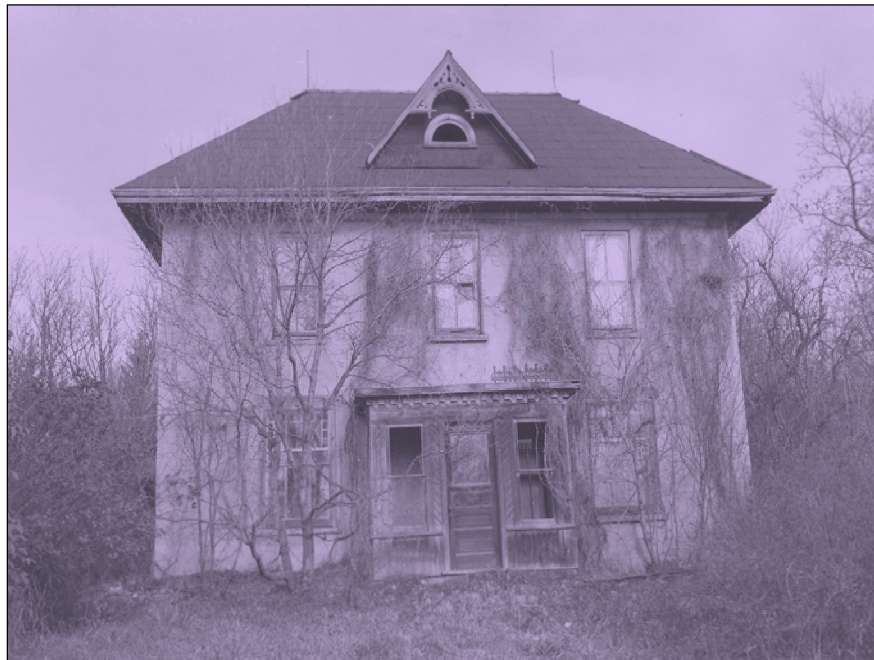
Figure 22
McKeand House, SW 22-11-17W, 1900.
The south facade of this large square-planned house has been overgrown with vegetation.

A house at SW 22-11-17W built by Robert McKeand was a standard example of these large square-planned houses (Figure 22). The 2½ storey square block was topped by a large truncated pyramidal roof. The south facade was symmetrically composed, with three windows on the second floor that lined up above a more elaborate ground floor. Larger windows, detailed with stained glass, opened into the drawing and dining rooms of the ground floor. The finely-crafted wood porch, with its delicate wrought iron cresting was likely a later addition (Figure 23). The other sides of the house were more informally handled.

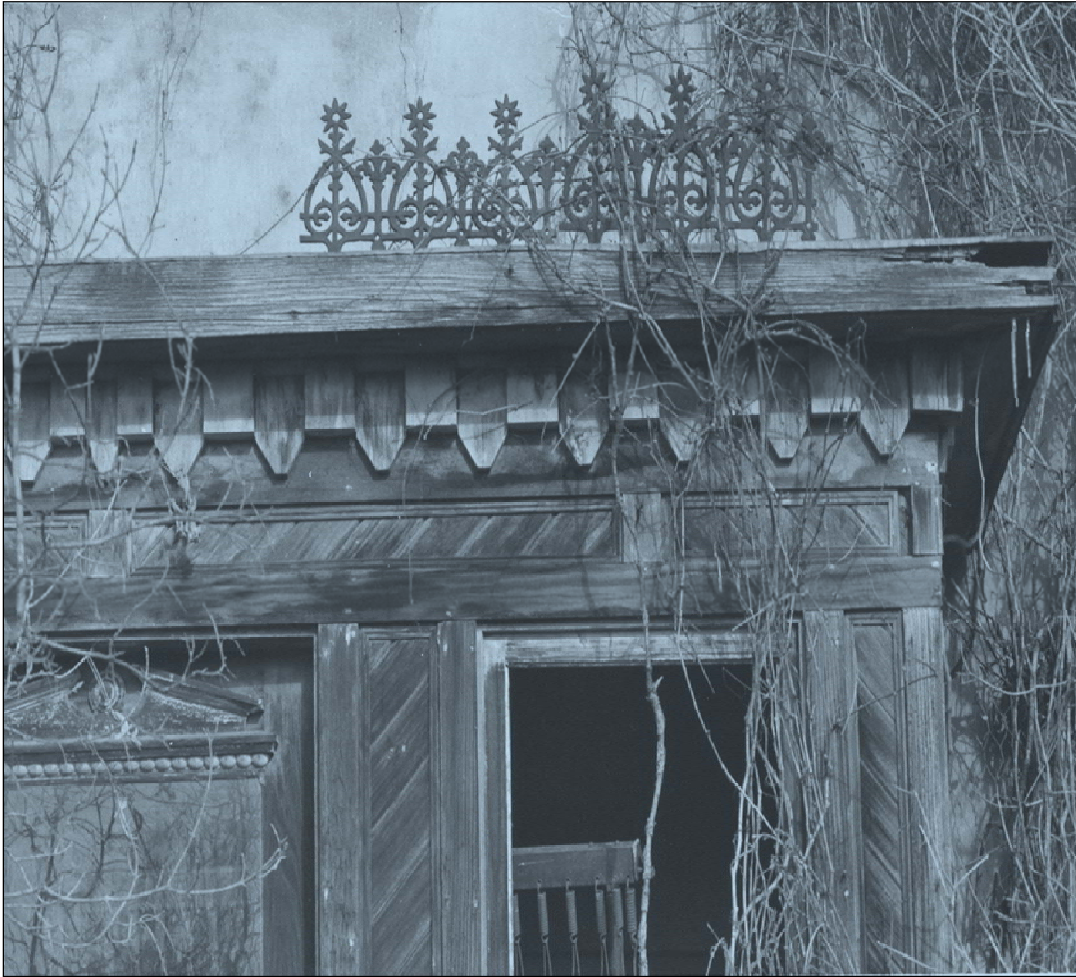
Figure 23
McKean House. The porch ornamentation on this house incorporated Eastlake-inspired details.

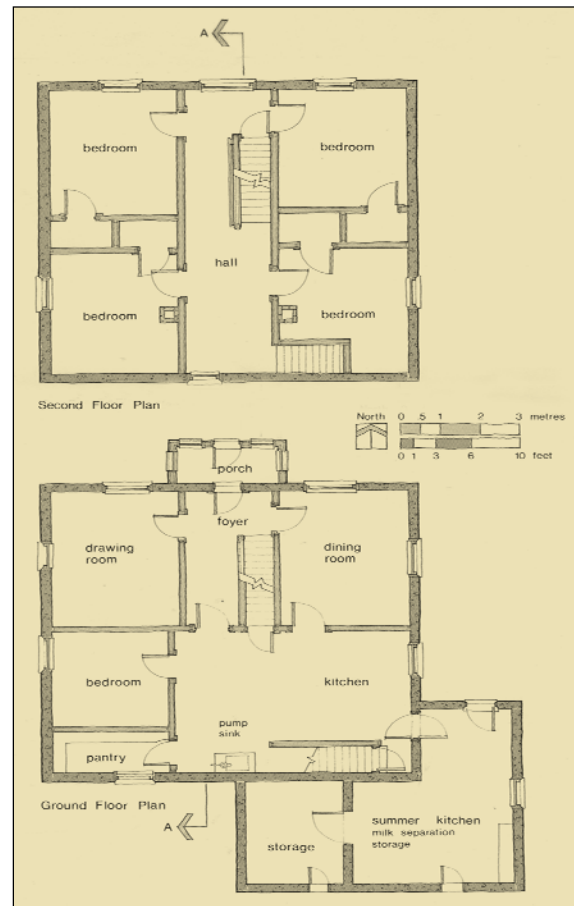
Figure 24
McKeand House: ground and second floor plans. The wide central hallway bisected both plans.

The internal planning of this large square house was dependent on the central hallway (Figure 24). The straightforward floor plans were enhanced by some decorative features. The more formal drawing and dining rooms had ceilings with inlaid pressed panels that were hand-painted by one of Mr. McKeand's daughters. The central staircase was also animated with distinctive newel posts and balusters. Finally, door and window frames added a light sense to the basic regularity of the design.

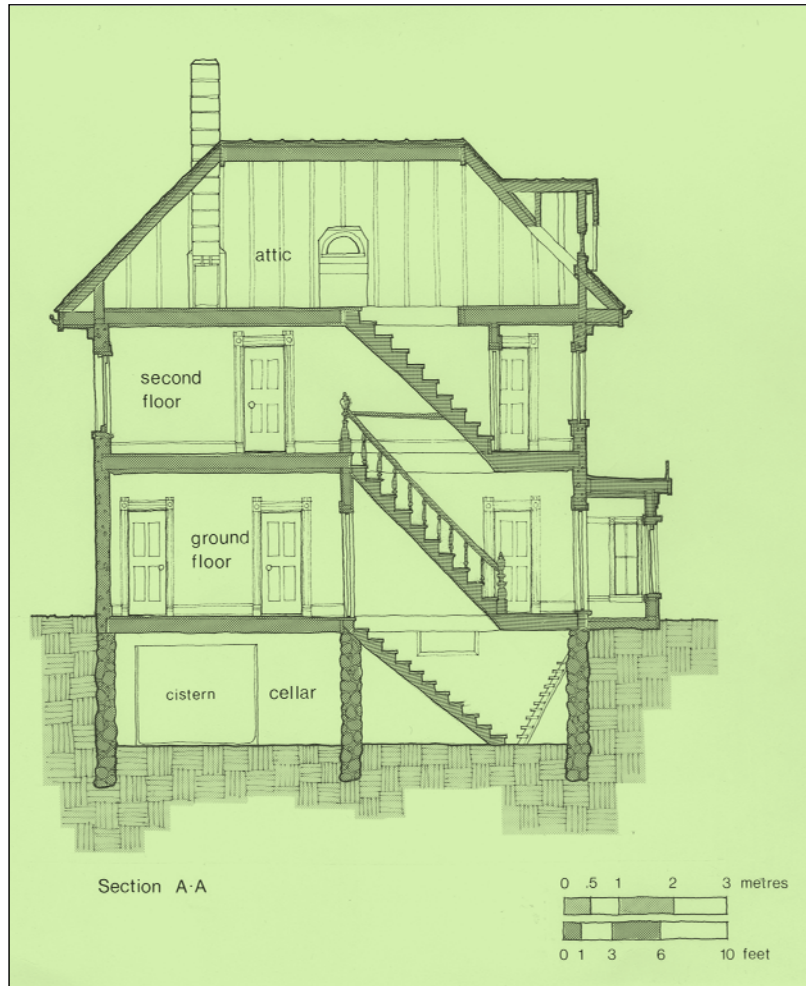
Figure 25
McKean House: section. While the foundation was fieldstone, the floors of the main structure were constructed using concrete.

The McKeand house was constructed of concrete. While wood framing with wood or brick veneer were more common procedures, there was a period after 1900 when concrete was accepted as a viable construction alternative. Itinerant builders roamed the countryside with portable block-making machines and for ten years concrete buildings, usually of block, were quite popular. Instead of blocks, however, the walls of this house were constructed using 300 mm (12") thick formed concrete. The monolithic walls not only provided fireproofing but with the plaster and lath interior, they improved heat retention. This large square-planned house also contained a heating system that was common in Western Canada. Stove pipes ran vertically from the furnace through all the rooms and then to the attic where the base of the chimney was located. In this manner the metal stovepipes were used to transfer heat to the rooms.

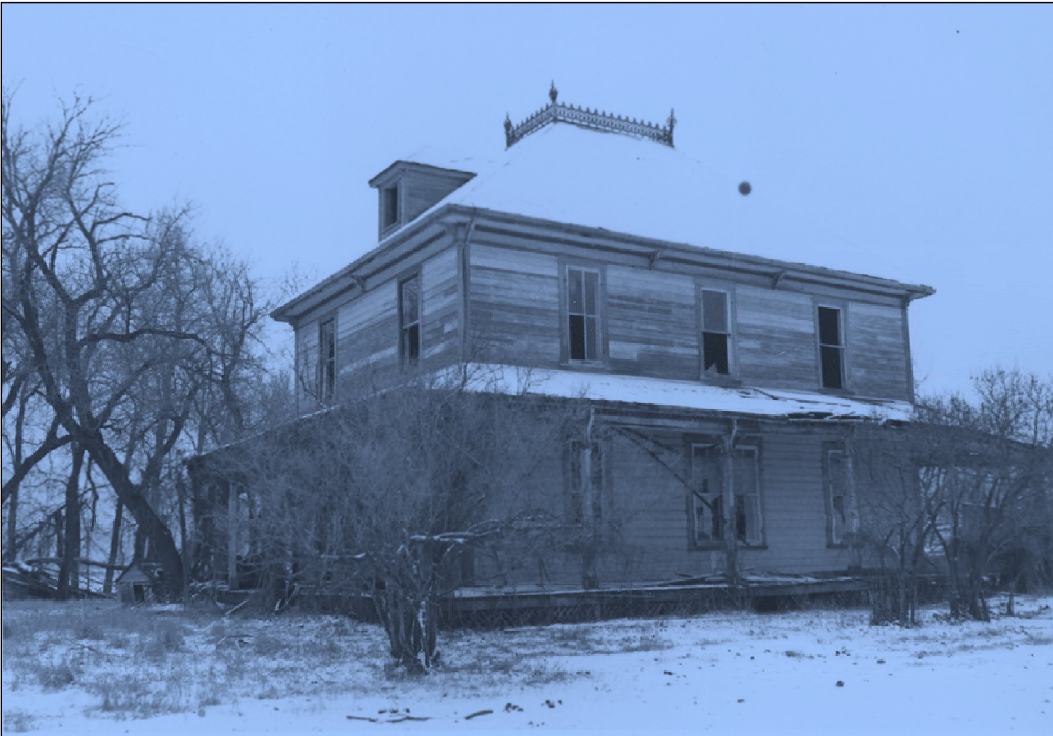
Figure 26

Roddick House, SW 16-9-18W, ca. 1910. This complex square-planned frame house has been abandoned for a number of years.

A large elaborate frame house at SW 16-9-18W (Figure 26) had a more refined sense of design than the McKeand house. Probably built around the same time, this 2½ storey residence was more richly detailed. The exterior had a verandah extending along three sides of the main floor, twinned first floor windows, moldings and brackets under the roof overhang and grillwork surrounding the roof walk (Figure 27).

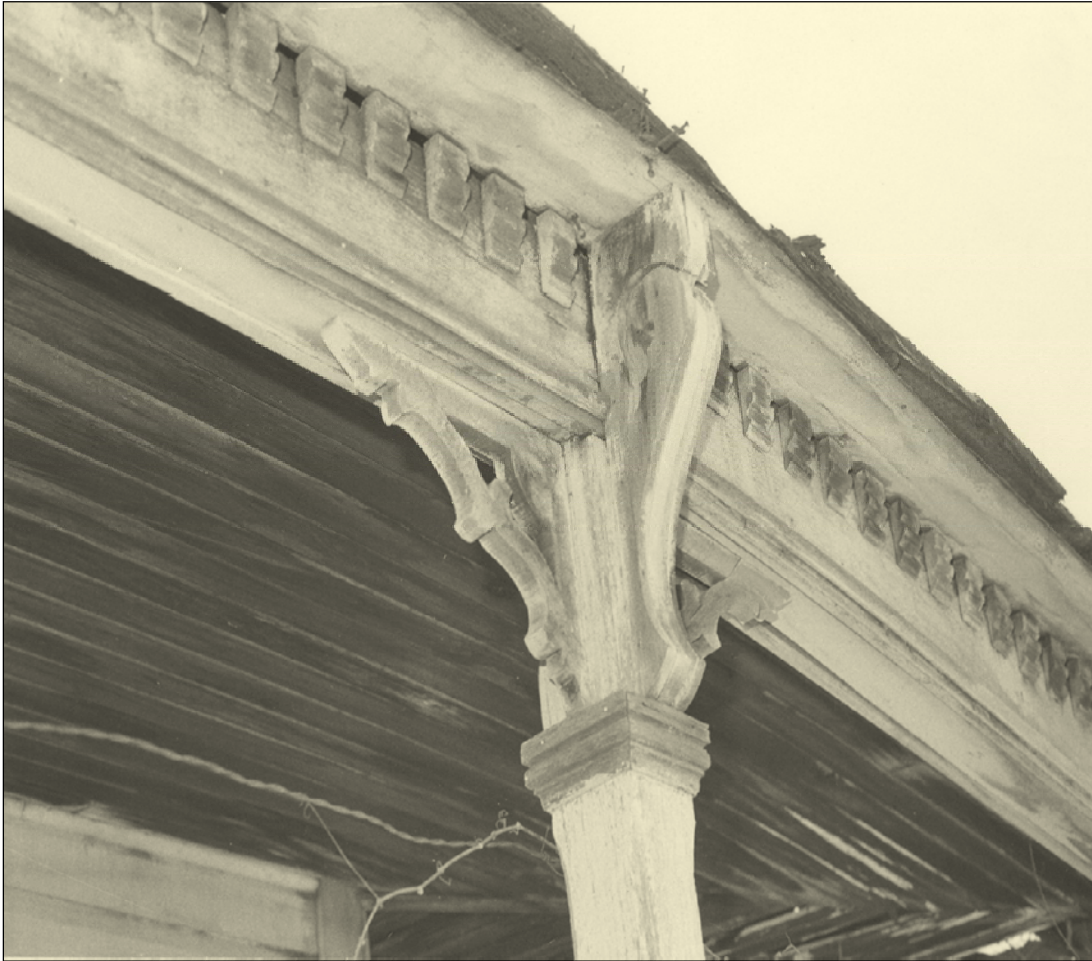
Figure 27
Roddick House. The intricate post caps on the veranda created a sense of lightness.

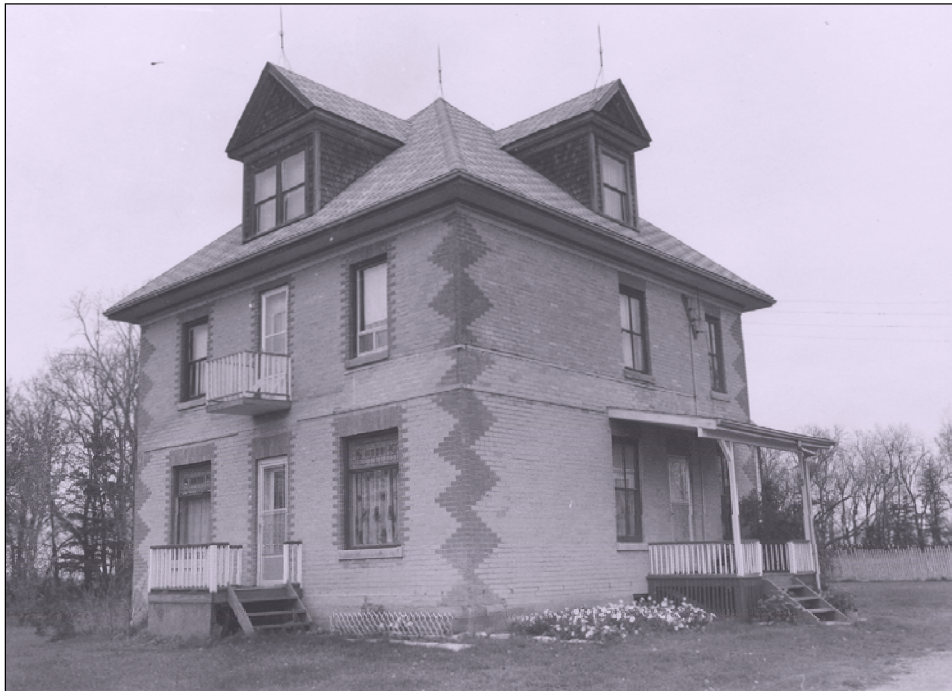
Figure 28
McPhail House, SW 5-12-18W, 1909. This brick veneer house was altered by the removal of a wrap-around porch.

Another large square-planned residence at SW 5-12-18W had a brick veneer finish that created a distinctive pattern on the walls (Figure 28). The inclusion of substantial quantities of expensive red brick indicate this farmer's status. Before 1910, yellow brick was more readily available than red brick, and the use of red brick at this time generally revealed a wealthy building. The workmanship of this expensive brick is somewhat inconsistent on this particular house, however. The quoins, especially, reveal some sloppiness. The walls create strange zigzags when seen together at the corners. However, a wrap-around verandah, now gone, probably concealed those irregularities. The brick detailing around the windows and doors is less ambitious, but more assured. The stained glass of the ground floor windows is a more elaborate reminder of the simple stained glass designs in the McKeand House.

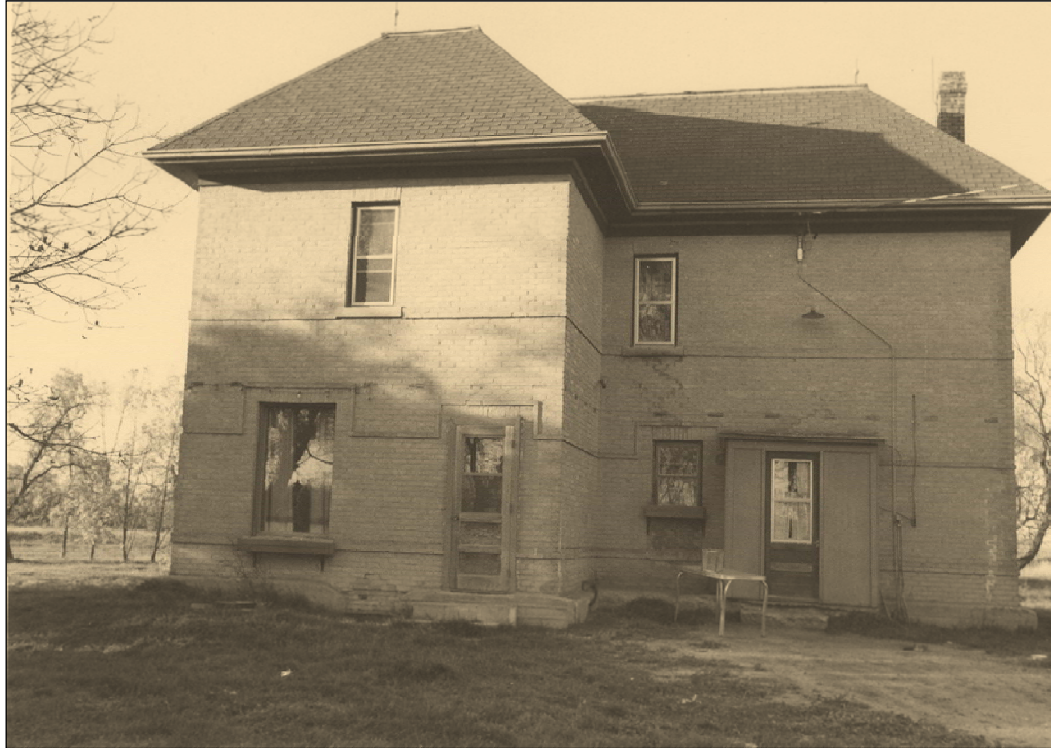
Figure 29
Cristine House, SW 17-11-19W, ca. 1890.
The exclusion of a verandah that was originally planned for this house provides an unobstructed view of the interesting brick detailing.

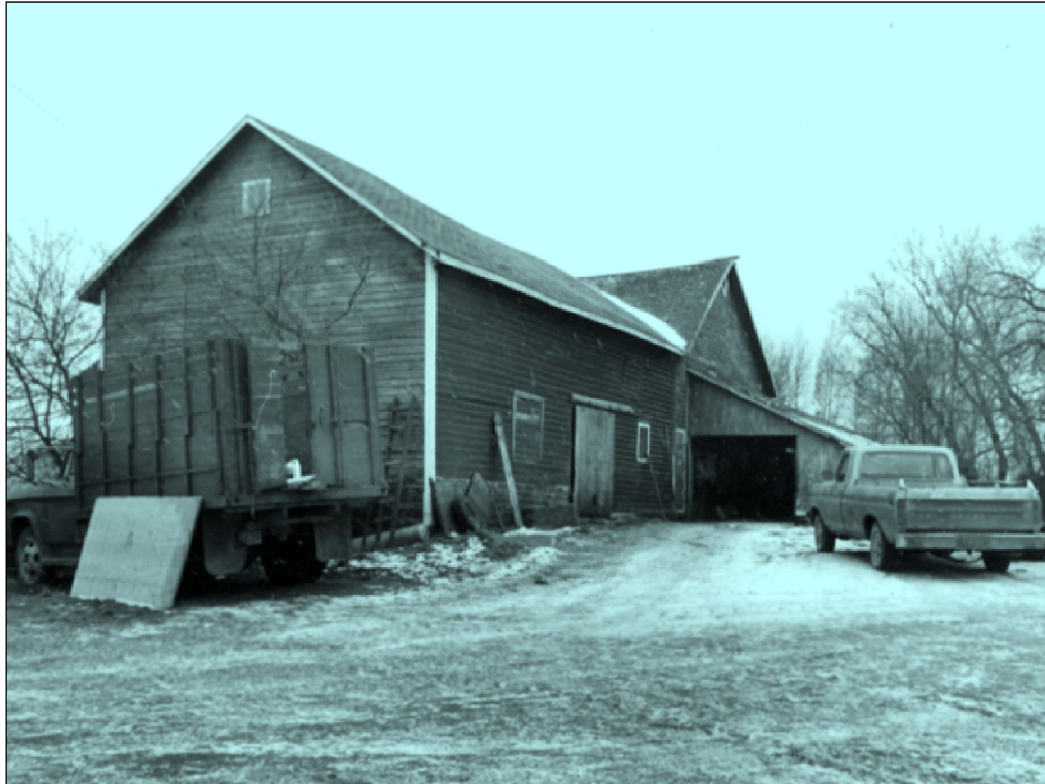
Figure 33

Hutton Barn, SE 4-10-19W, ca. 1885. The original bank barn, from the northeast, shows the hillock that provides upper level access to the loft. This section has square nails, a feature helpful for dating nineteenth century construction.

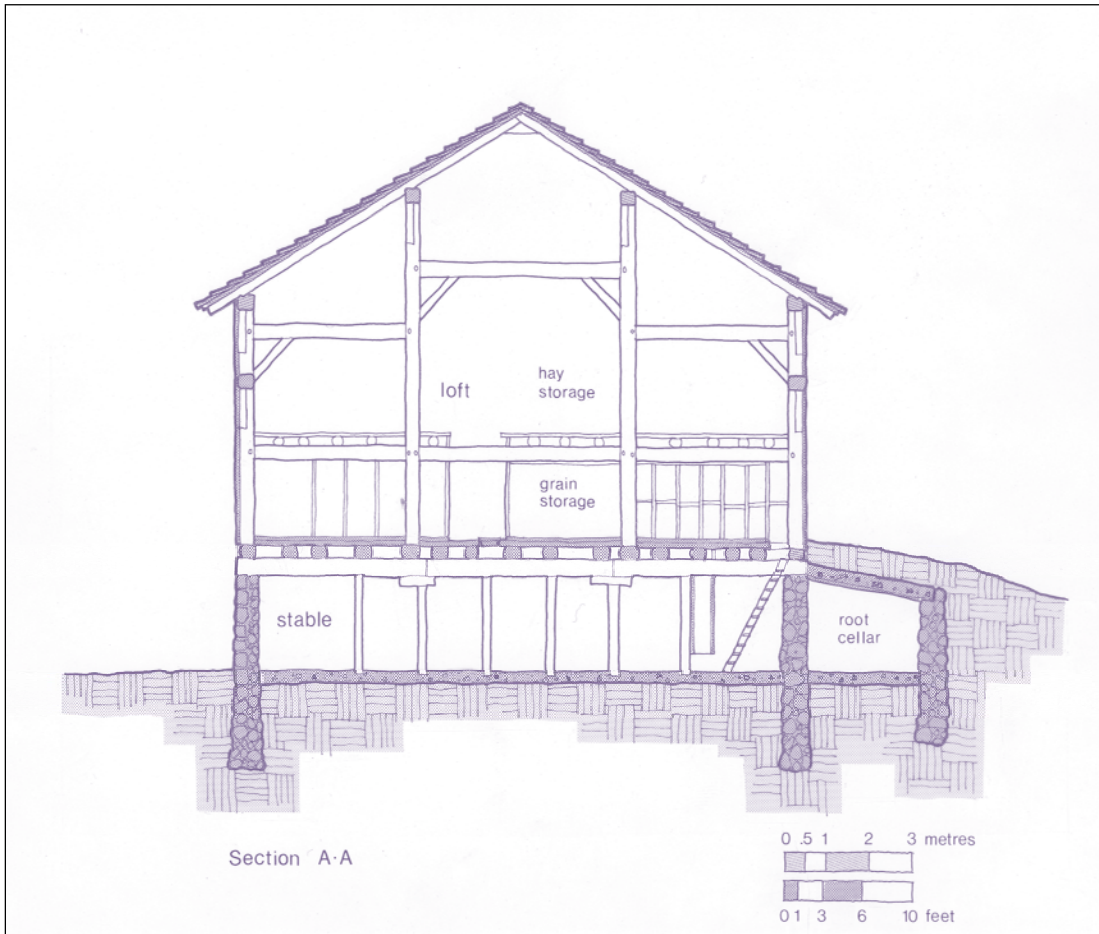
Figure 45
 McCallum Barn: section. This cross-section shows the heavy fieldstone foundation walls, the root cellar under the built-up ramp and the loft bentwork.
