ANGLO-ONTARIO FARM BUILDINGS

An Architectural History Theme Study

David Butterfield
Historic Resources Branch

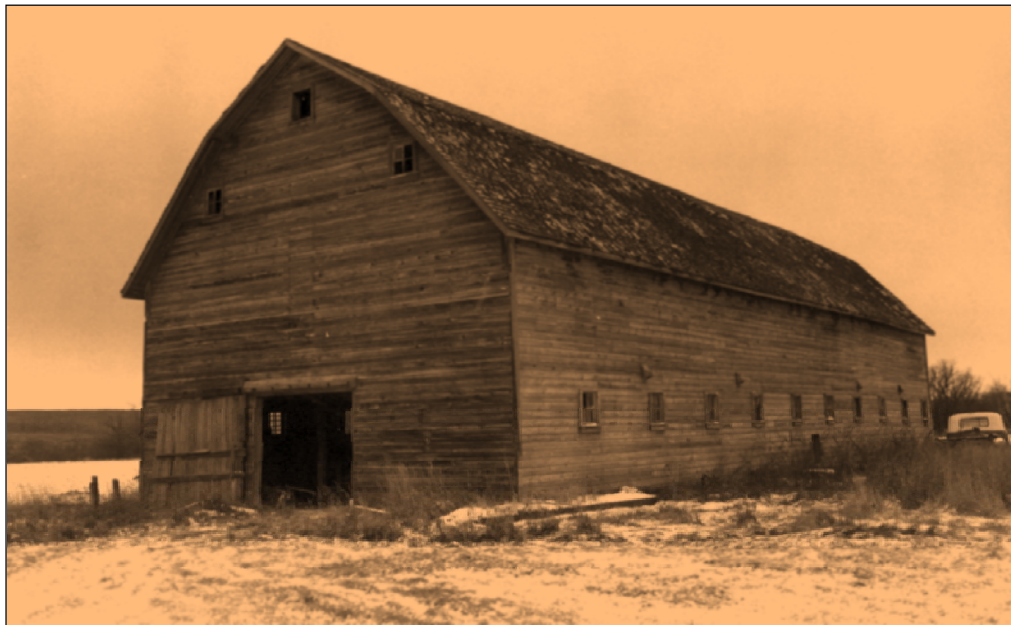
Figure 53
Roddick Barn, SE 17-9-18W, 1904.

In the Brandon Hills the settlers from Nova Scotia introduced a structural system that also created a more open loft (Figure 53). Each bent was connected to the next only by a purlin; the welter of horizontal connectors that provided external wall and loft stability in southern Ontario style barns were excluded in Nova Scotia style barns (Figure 54). The simpler bent arrangement permitted much easier movement in the ship-like loft. However while hay slings were often incorporated inside these barns, there was no easy source of access into the loft. The southern Ontario style north ramp was not included with Nova Scotia style barns and grain had to be thrown into the loft through 1200 x 1200 (4' x 4') hatch doors.

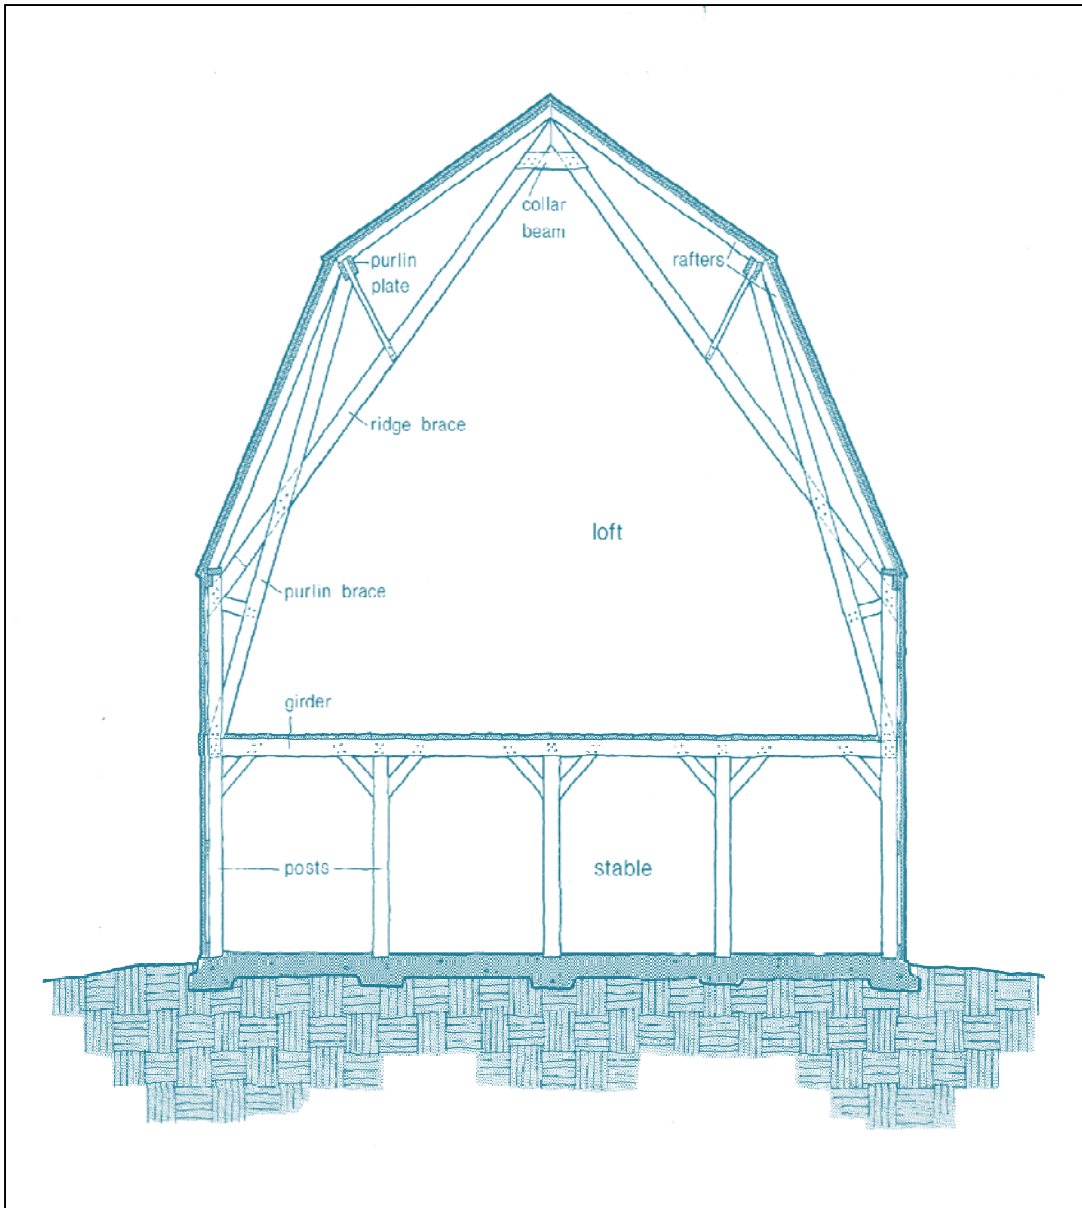
Figure 55
Plank-framed gambrel-roofed barns were built around the turn of the century.

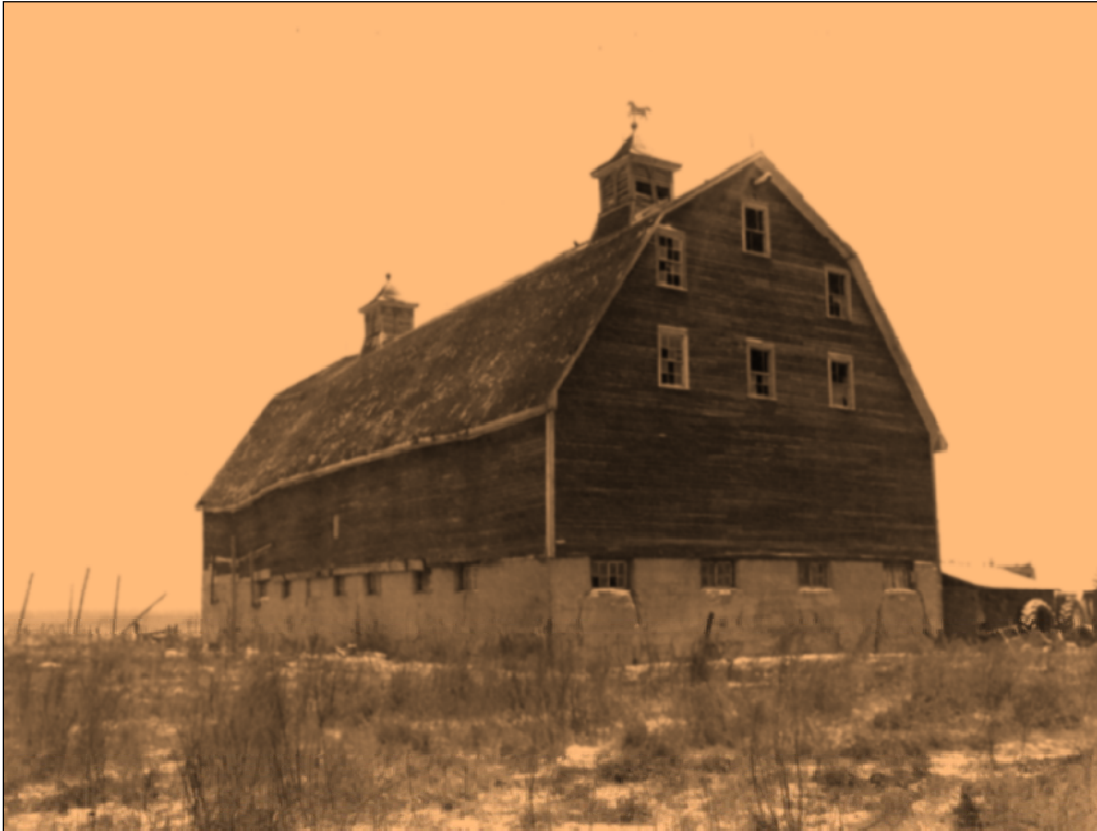
Figure 56
Shields Barn, NW 18-9-19W, 1910-12:
southeast view.

Barns built with plank framing were ambitious in design and scale. The Shields barn, built from 1910 to 1912, at NW 8-9-19W, reveals the advanced state that barn building in the Brandon area had attained (Figure 56 and 57). While the barn was built with concrete stable walls and was not planned with a long central alley, the huge open loft was very modern (Figure 58). Constructed using a series of plank trusses, the voluminous space in the loft allowed a hay sling complete freedom of movement along a track in the roof peak (Figure 59). Hay and grain could be lifted from wagons on the east side and shifted easily through any part of the loft. The Shields barn was built as a physical and technical rival to the new livestock barn at the Brandon Experimental Farm. The barn at the experimental farm burned in 1916 and the Shields barn now stands as one of the few remaining large truss-roofed barns in the Brandon area.

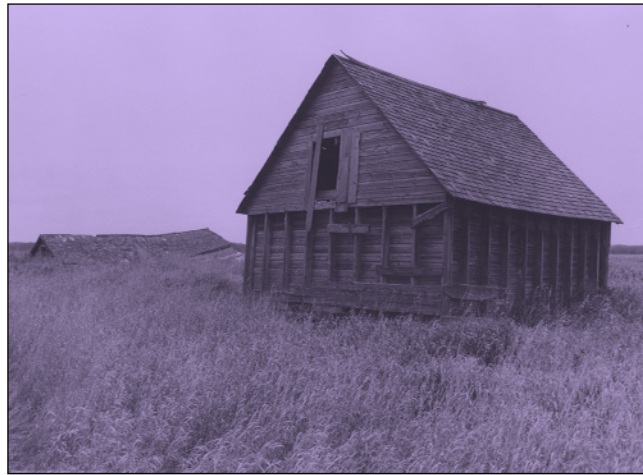
Figure 61
Granary, NW 13-9-10W. The hatch in the gable end was used for loading and unloading the grain. Bags of grain were usually pitched from a wagon up to the opening.

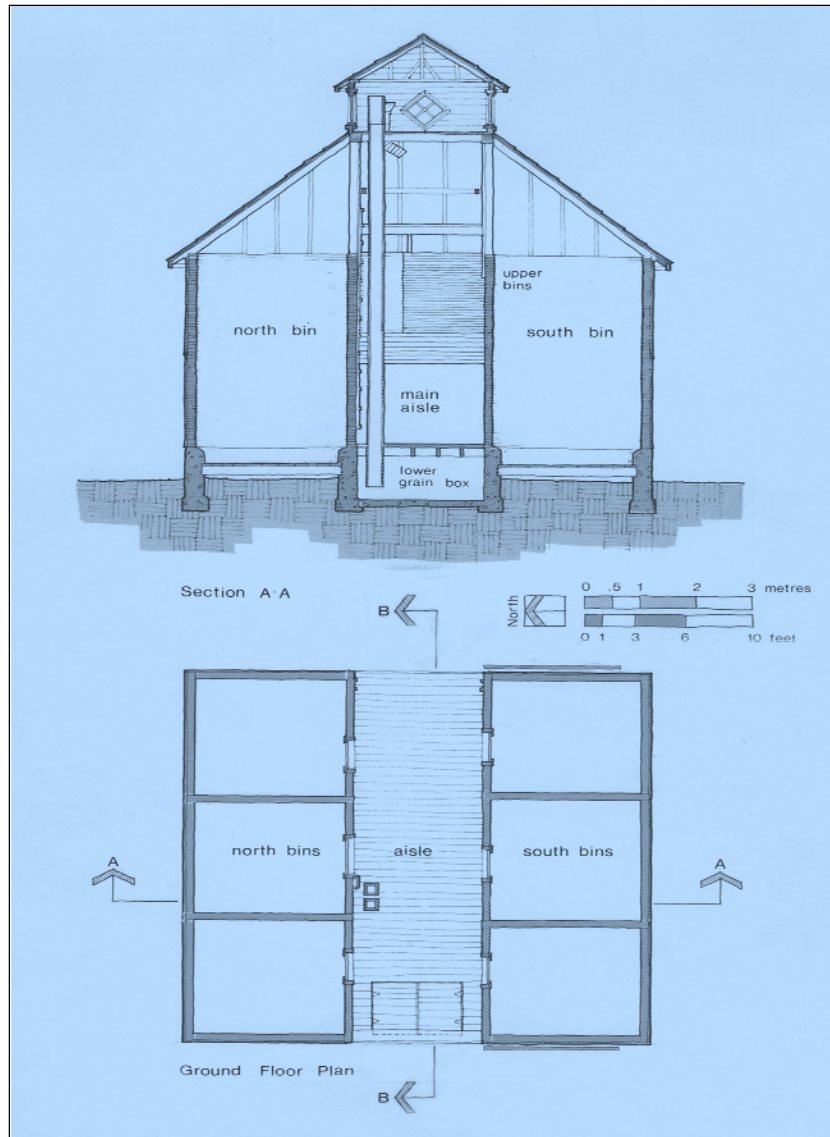
Figure 64
McCallum Elevator: ground floor plan and section. The cribbed bin walls were constructed of stacked 40 x 80s (2" x 4"s).

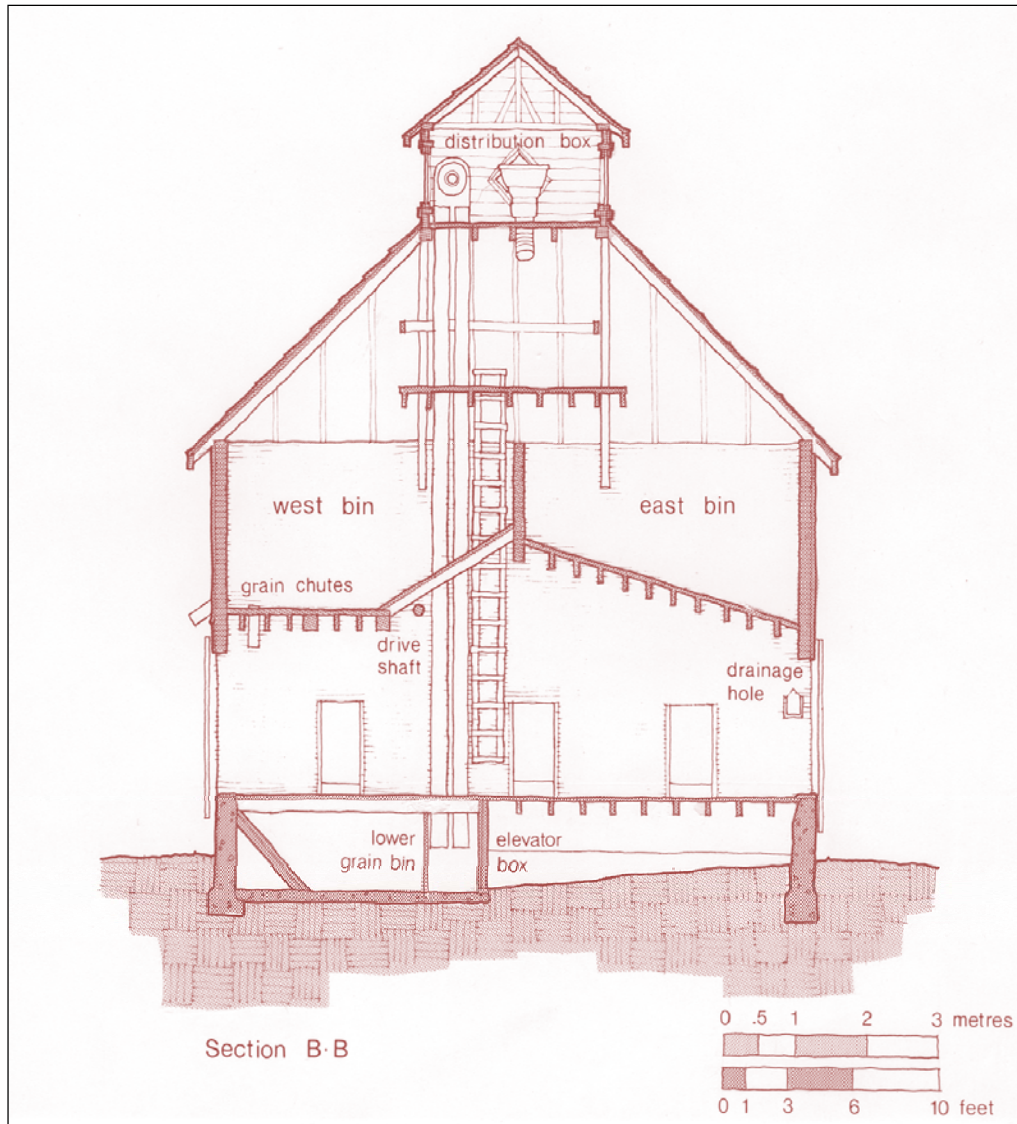
Figure 65
 McCallum Elevator: section. The capacity of this elevator was 68,280 litres (7850 bushels).
